Castle Rock Edinvar

Scottish Energy Centre joined CastleRock Edinvar whilst undertaking a feasibility study investigating the fabric improvements that can be achieved through by retrofitting envelope improvement system into a 1930's office space.

In-situ measurement results

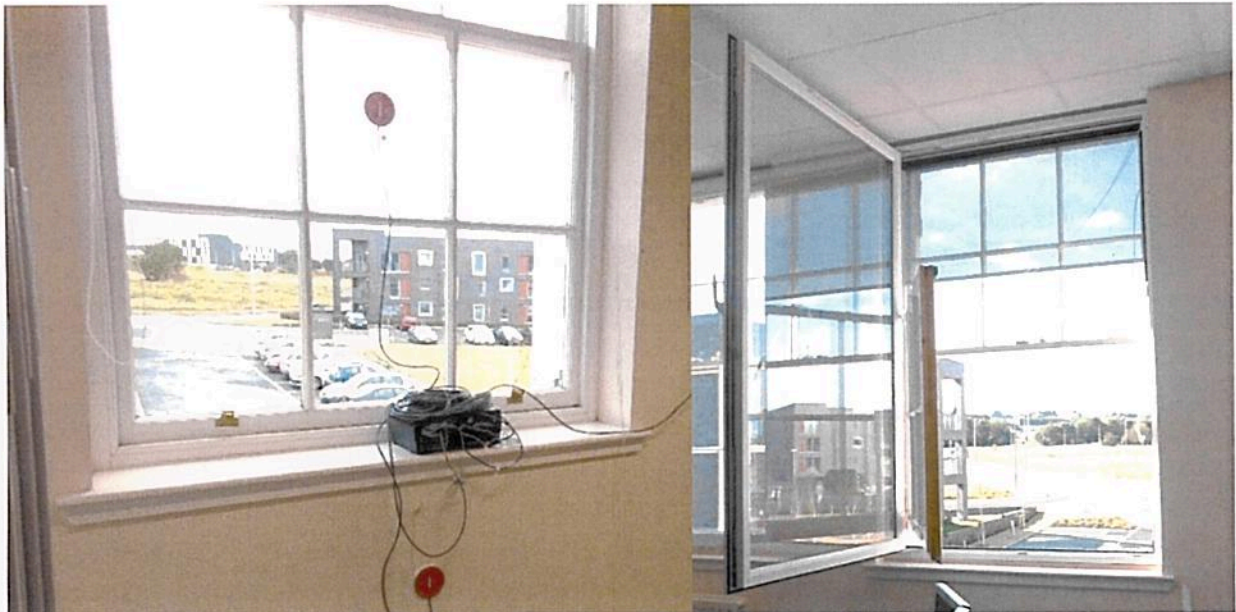
Plate 1 [Left]. Plate 2 [Right]

The windows in the South facing facade tested in the study are single glazed timber sash and case window (Plate 1) these are representative of all the windows along the listed front facade. During the refurbishment the windows in the test room were thermal enhanced with the installation of toughened low-e double secondary glazing unit in an openable uPVC frame with trickle vent added to the four windows. The secondary glazing unit called Thermal Shield developed by Adam Dudley Architects of Edinburgh, is installed internally with approx. 100mm gap between glazing units and the existing window. Additionally a novel radiant heat barrier window blind installed between glazing units (Plate 2).

Building element	Control room (Existing fabric) U-value (W/m <sup>2</sup> K)	Enhanced room (Refurbished fabric) U-value (W/m <sup>2</sup> K)
Glazing	5.2	0.6
Wall: above ceiling tiles window header	0.43	0.24
Wall: below window	0.36	0.12
Wall b: top of wall below ceiling tiles	1.11	0.53

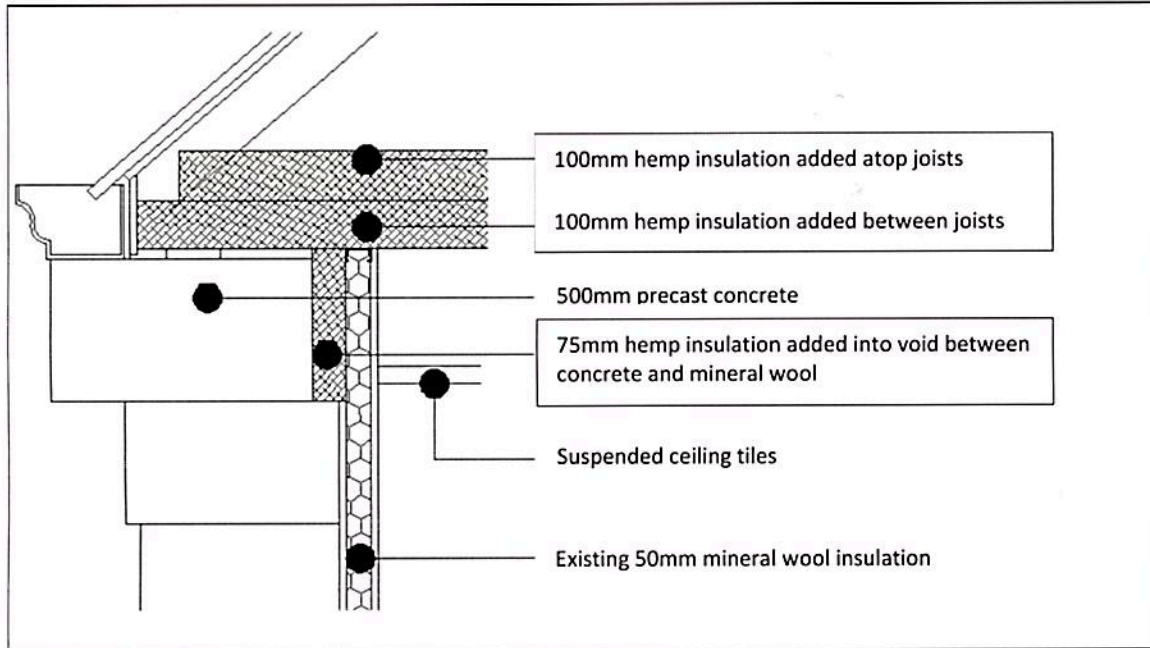
Heat flow mats were applied to the area above the suspended ceiling and between each of the windows. The elemental build-up of the existing structure consists 500mm precast concrete lintel, 75mm unventilated air gap, 50mm mineral wool insulation, 12.5mm plasterboard on 50mm metal framing. During the refurbishment stage 75mm hemp insulation added to air gap between concrete lintel and mineral wool (see Plate 3).

Plate 3. Materials added during 2012 refurbishment highlighted in black outline

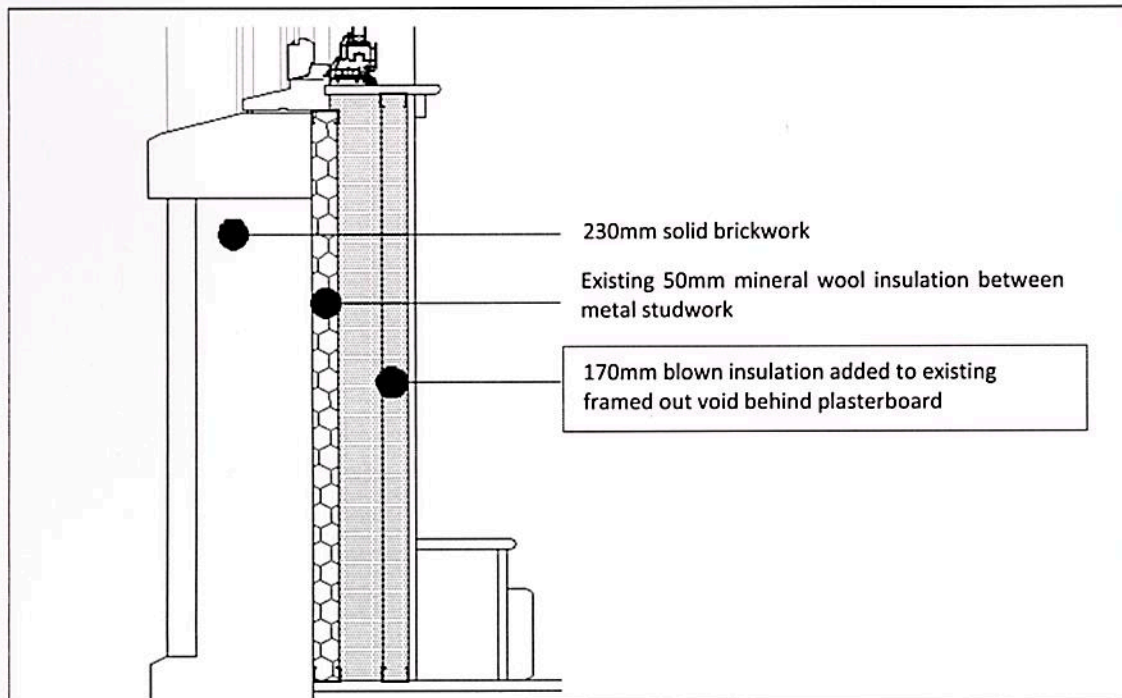
The area below the windows on the South facing façade is built-up of 25mm roughcast external render, 230mm solid brickwork, 50mm mineral wool insulation, 170mm unventilated air gap, 12.5mm plasterboard internal lining. The refurbishment work included 170mm of bead insulation blown into the gap between mineral wool and plasterboard (Plate 4).

Plate 4: Materials added during 2012 refurbishment highlighted in black outline

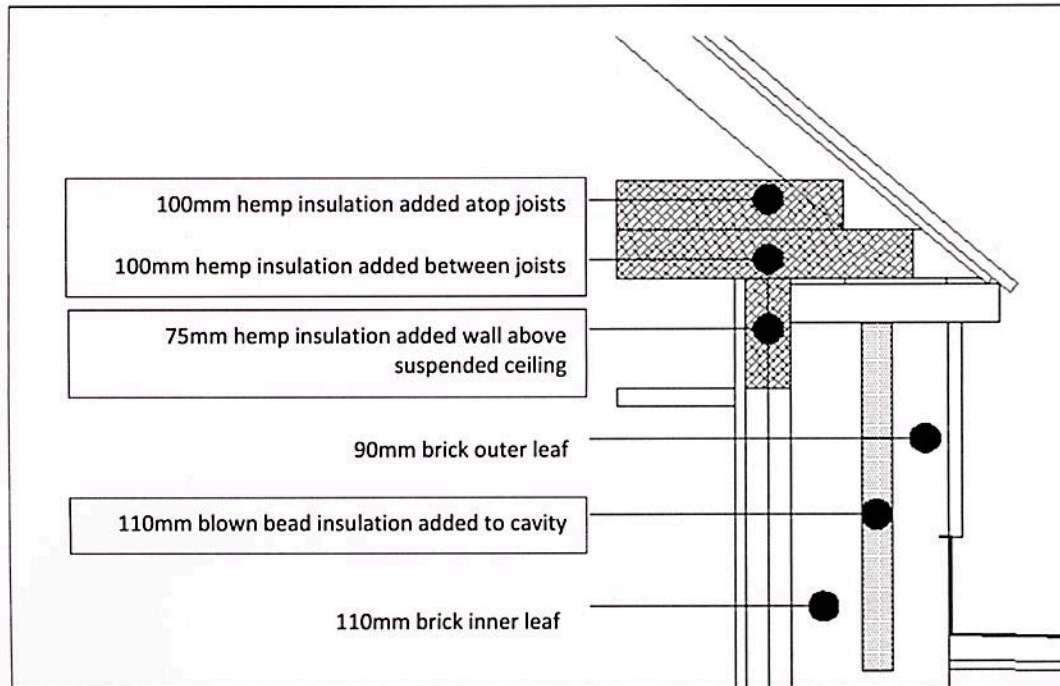
A small portion of the North facing wall in the main offices is a non-list cavity wall with the upper portion being an external wall. This upper external wall consists of 25mm roughcast external render, 90mm solid brickwork, 110mm cavity, 110mm brick, 50mm unventilated air gap, 50mm metal stud framing finished internally with 12.5mm plasterboard. During refurbishment 110mm blown bead insulation was pumped into the cavity between the brick leaf (Plate 5). Further to this hemp insulation was installed to the cavity behind the plasterboard and to the overhead joists to form a continuous insulating layer in an attempt to mitigate cold bridging.

Plate 5: Materials added during 2012 refurbishment highlighted in black outline
